FINAL REPORT
9438 HIGH LEVEL TRAVELING
WAVE TUBE AMPLIFIER *ANOMALY*

VOLUME I

Prepared by
J. A. Durschinger
TRW, Inc.
TRW Defense and Space Systems Group
One Space Park
Redondo Beach, CA 90278

11 August 1978

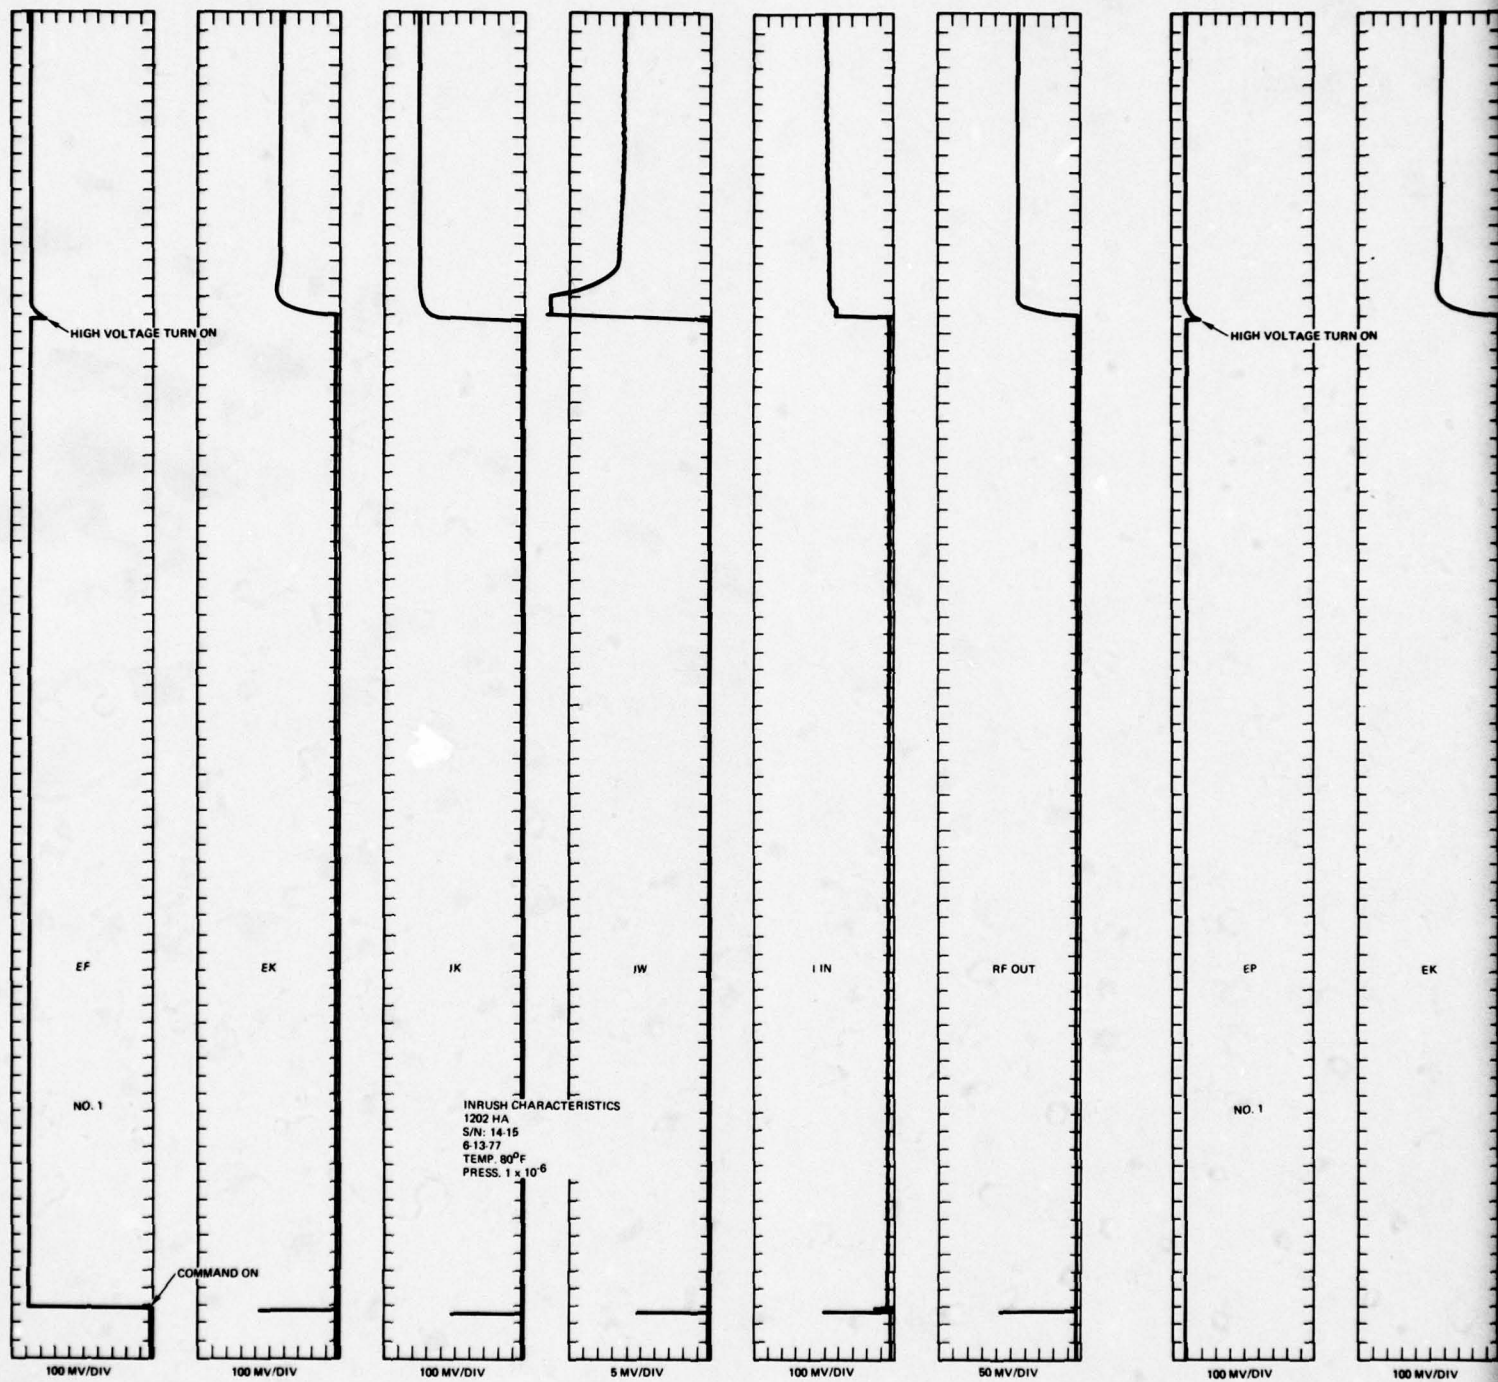
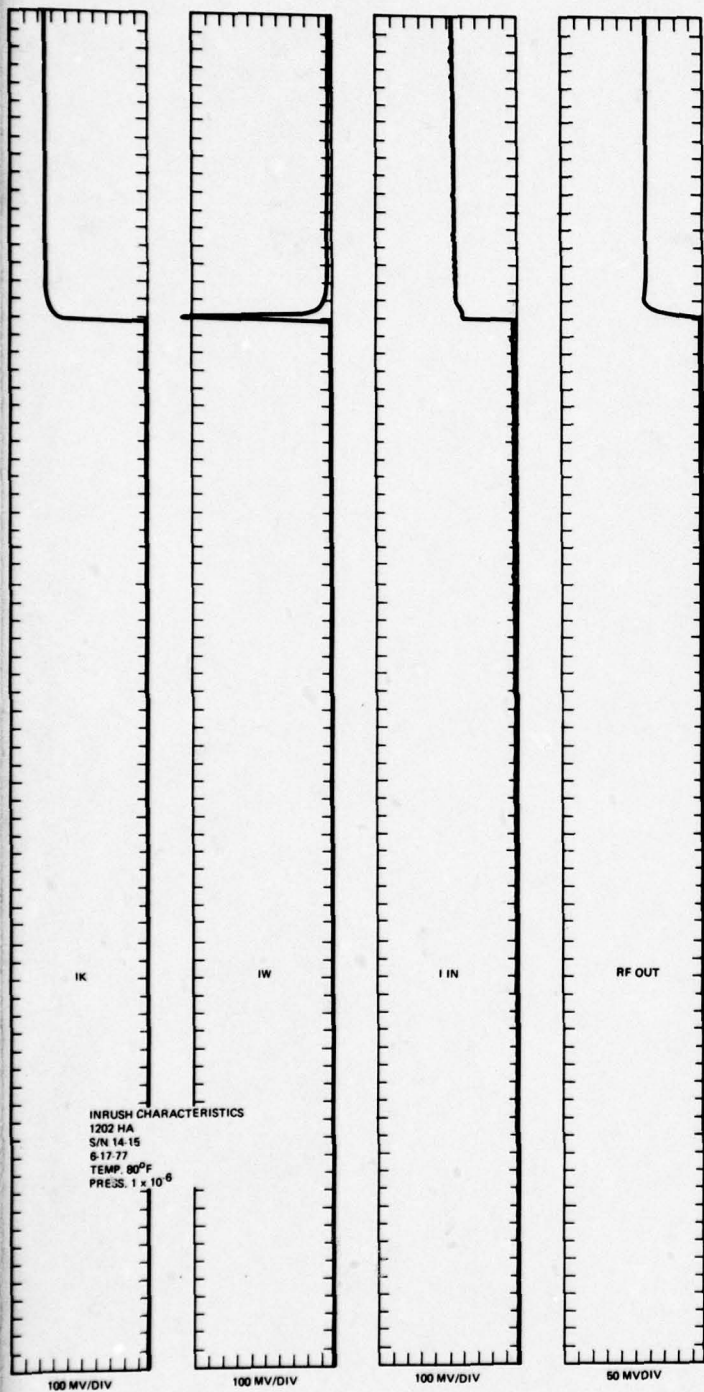
Figure 8-3.2. Turn on Characteristics for HLTWTA S/N 14-15 in Vacuum on 6/13 and 6/17/77

curves does not show any significant difference between amplifiers. Of particular interest is a comparison between S/N 14-15, the TWT which subsequently failed, and the others which did not. Again, the variation between amplifiers which survived the thermal vacuum test is greater than the variation between 14-15 and the rest. The unusual turn-on characteristic of the F8 HLTWTA-1 stands out as different. However, any attempt to explain it can be expressed in only the most speculative terms, and the short-term failure of 14-15 and 24-26, which showed nominal turn-on characteristics, precludes using these data to screen out amplifiers of short life.

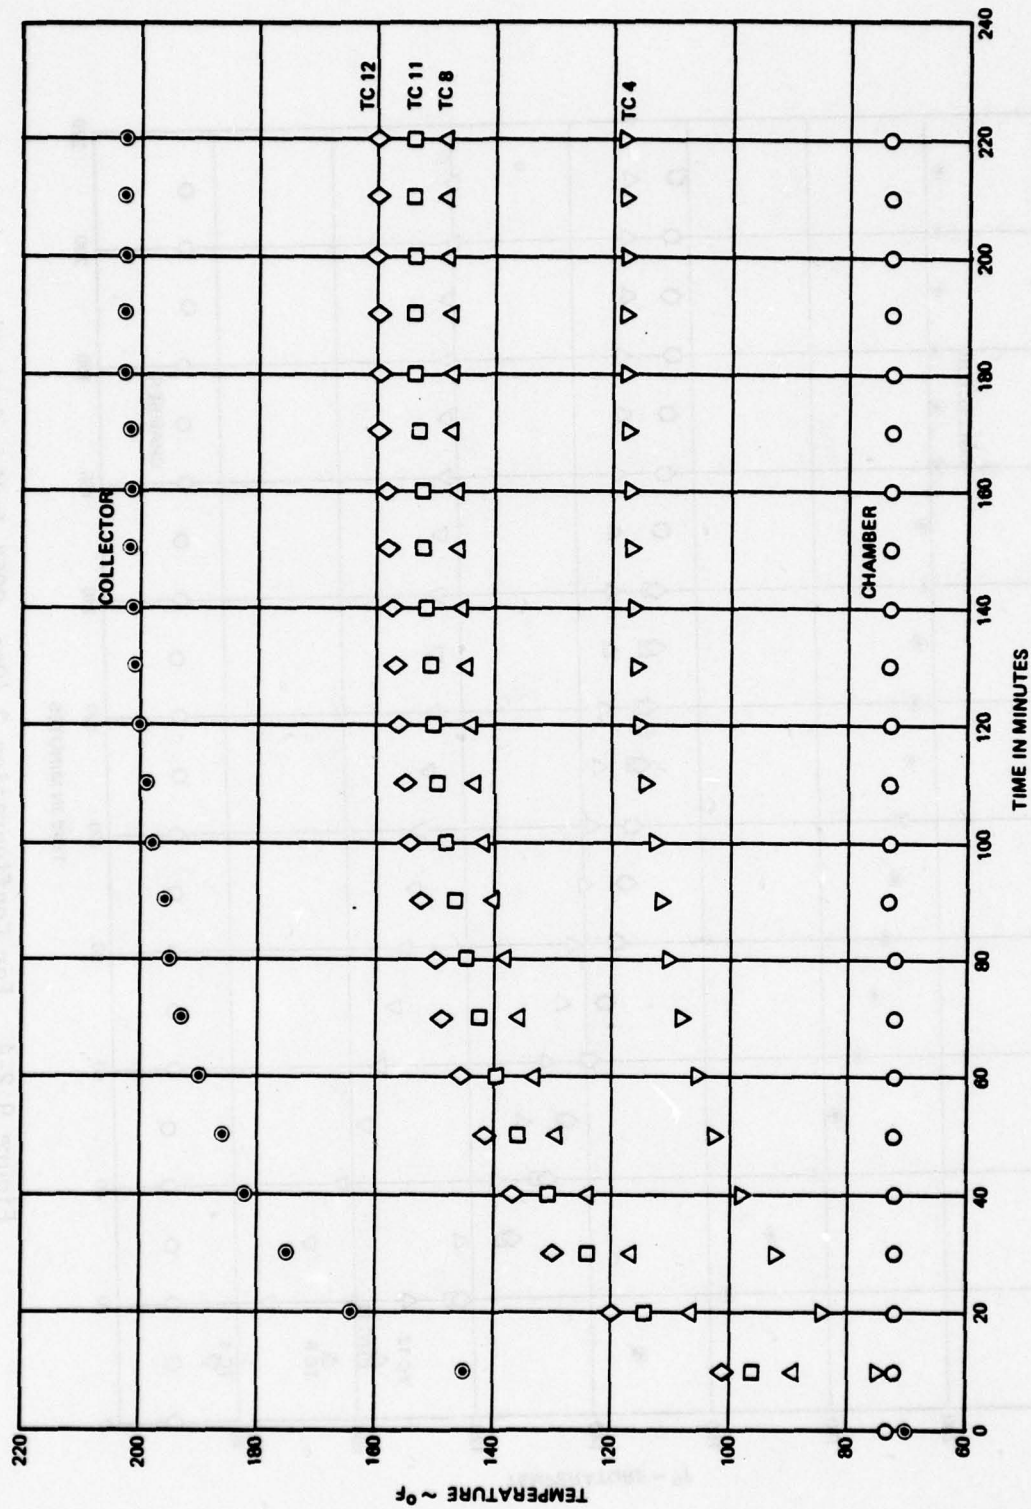
Test configuration three was the then existing flight configuration. As shown in Figure 9.2-3, the maximum collector temperature was 203°F. The platform reference temperature corresponding to a flight telemetry measurement was 113°F. It was determined from these tests that a single 0.005-inch indium gasket configuration (Configuration No. 2), where only three screws (P1, P3 and P4 in Figure 9.2-1) were installed through the platform plug into the TWT baseplate, would provide an equally good thermal interface for the TWT. This configuration was subsequently chosen for use on F9 through F12 (the remaining satellites using the 20-watt TWT). As shown in Figure 9.2-4, the maximum collector temperature was 201°F. A more detailed test report is included in Appendix D.

Figure 9.2-3. For the Reference Configuration (No. 3) the Maximum TWTA Collector Temperature was 230°F at a Chamber Temperature of 74°F

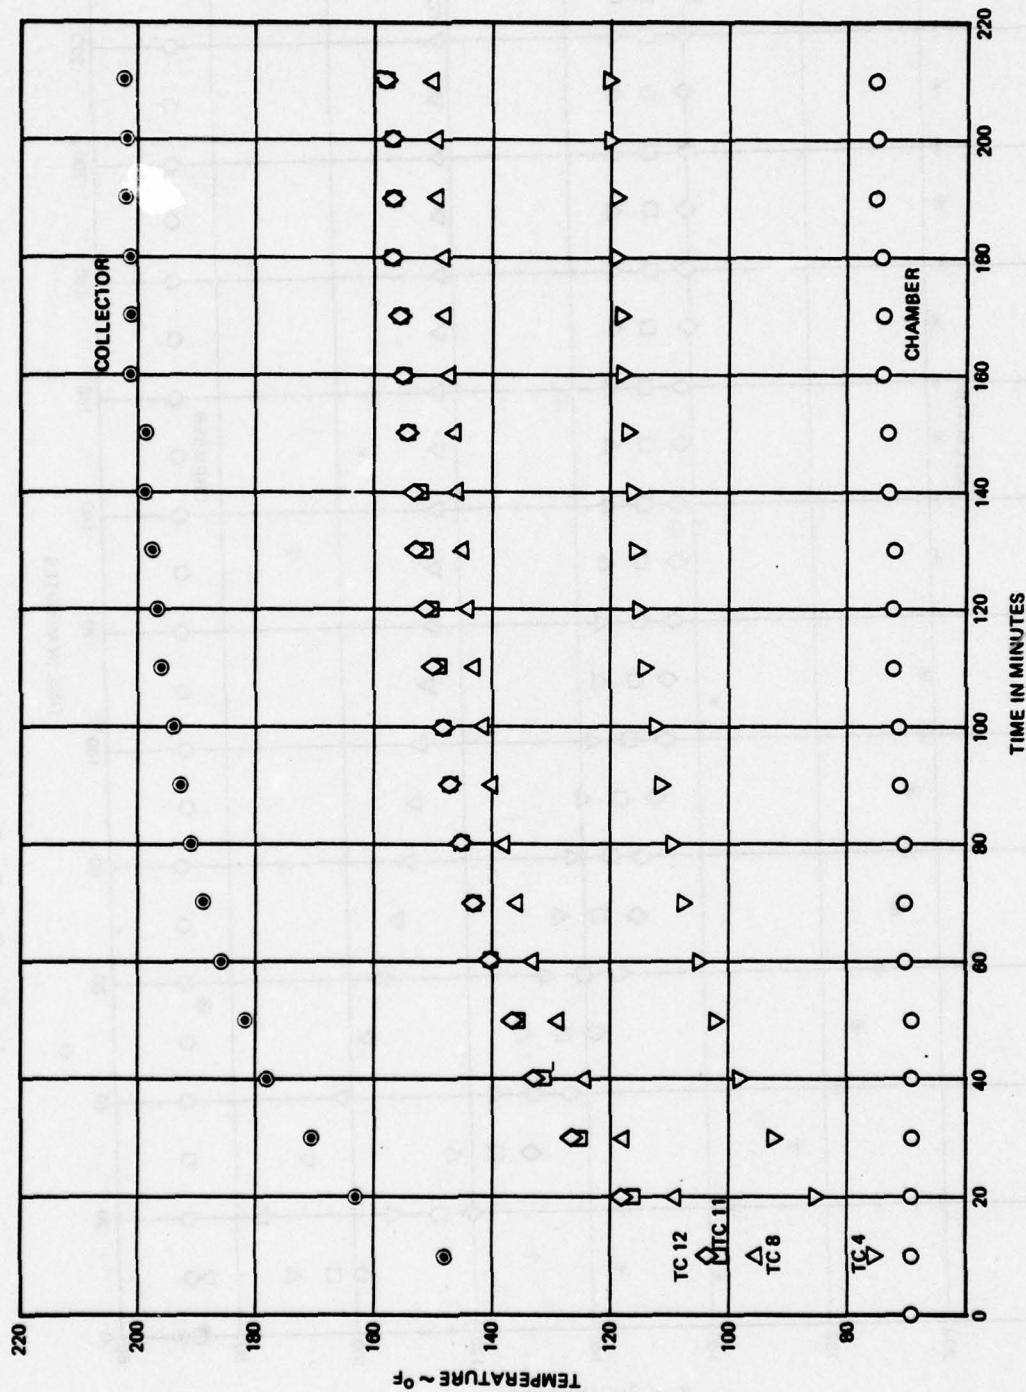
Figure 9.2-4. For Configuration 2 (One .005" Indium Gasket).
The Maximum TWT Collector Temperature was
201°F at a Chamber Temperature of 74°F.

solder, beryllium, copper, and aluminum. A schematic representation of the computer model is shown in Figure 9.1-2. This analysis concluded that the stepped indium gasket configuration did not induce structural failure of the TWT. It did contribute to the already existing internal thermal stress and strains within the TWT collector end assembly. The analysis showed the solder and copper layers on both surfaces of the beryllium insulation would yield a small amount. Also, the potting compound and conformal coating yielded a small amount under the combined thermal and mechanical stresses. A quantitative summary of the analysis results are given in Table 9.1-1. The area at which the maximum strain exists in the conformal coating and potting compound is shown in Figure 9.1-2. It should be noted that after this investigation, the mounting configuration has been changed to a single 0.005-inch indium gasket for F9 and subsequent satellites.
